DESMOINES LAKE MEETING 1

Dave Ferris, Burnett County Conservationist Tom Boisvert, Burnett County AIS Coordinator

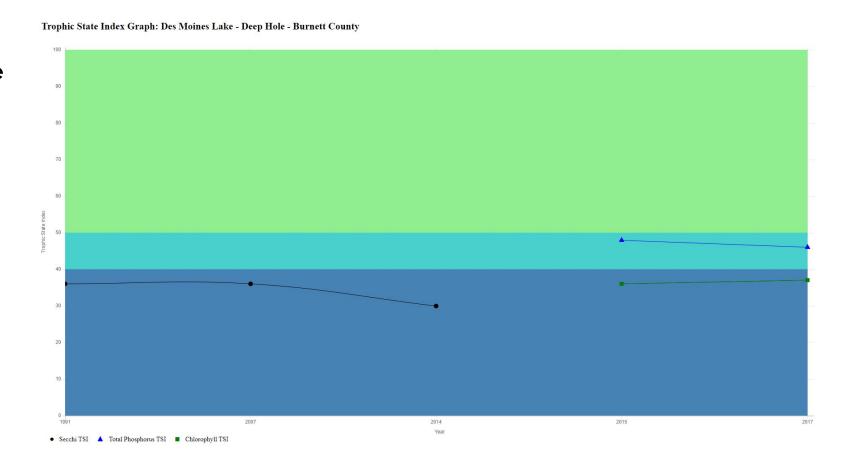
The clearer the water the less algae are present. This can give insight to the lake's productivity.

We use Secchi disks to measure this.

More consistent secchi disk monitoring will show this relationship clearer.

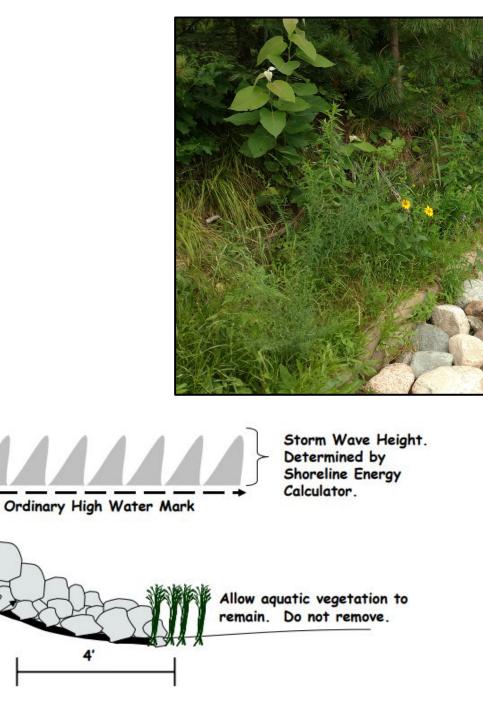
RIP-RAP

Native vegetation to be seeded from the OHWM to the top of bank along entire shoreline. Woody vegetation, such as shrubs, will compose at least 50% of the seed mixture.

2:1 Side Slope

Filter Fabric

Varying sizes of clean field stone from 6-24" in diameter

Restoring/preserving shoreline buffers, rip-rap, shoreline socks, erosion logs, etc. can be used to mitigate erosion problems caused by high water.
